Re: ACD FREE Modification Proposal

Date: 3-5-2004

Summary:

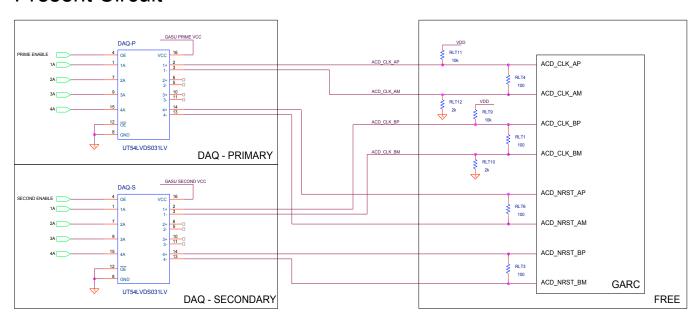
Present Circuit

The proposed modification involves cross-strapping the clock and reset inputs to allow a portion of the transmitted signal to be seen by both sets of receivers. The circuit as it presently exists on the FREE card is shown below:

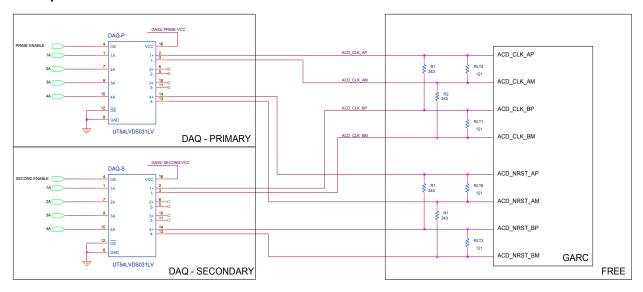
Proposed Circuit

The schematic of the proposed fix to the flight FREE cards is shown below:

Total termination impedance using the 121 Ω resistors at the receiver inputs and the 243 Ω cross-strapping resistors is:

$$Z = \frac{(121)(243 + 121 + 243)}{121 + 243 + 121 + 243} = 100.9\Omega$$

which is close to the desired 100Ω termination.

The proposed change is to be made on both the clock and the reset signal paths. If both the primary and redundant clock receivers can be active, it is necessary to ensure the reset level is held inactive.

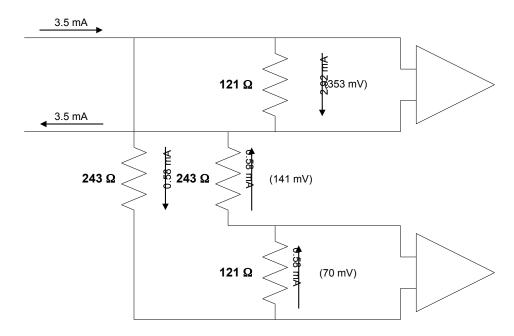
The calculated signal amplitudes based on nominal LVDS currents are shown below:

The primary (powered) receiver maintains the ~ 350 mV signal across the 121Ω resistor with 2.92 mA of (nominal) current. $580 \,\mu\text{A}$ current is shunted through the 243 ohm resistors and the redundant (unpowered) receiver. This provides ~ 70 mV of difference across the unpowered receiver, which is enough to toggle the GARC receiver in the absence of cabling reflections.

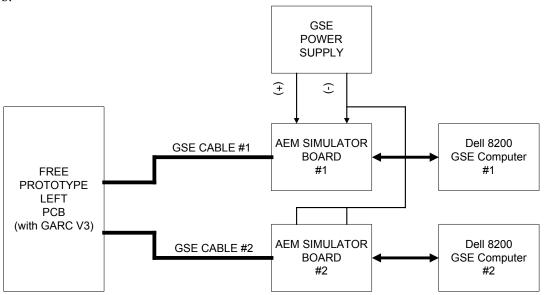
This modification has been tested on the bench with a setup that is similar to the flight configuration (we will retest with the GASU when it becomes available). The test setup was as follows:

In this setup, AEM simulator board #2 was kept powered off with the power leads shorted together and tied to ground. This is to simulate the redundant (unpowered) DAQ card in the GASU.

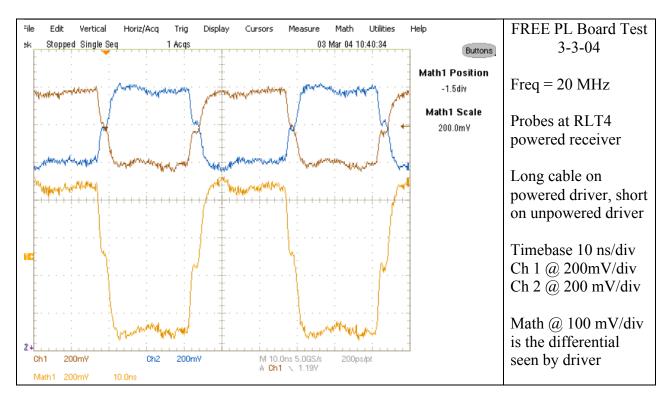
Powered receiver, 20 MHz, Differential signal is ~ 700 mV

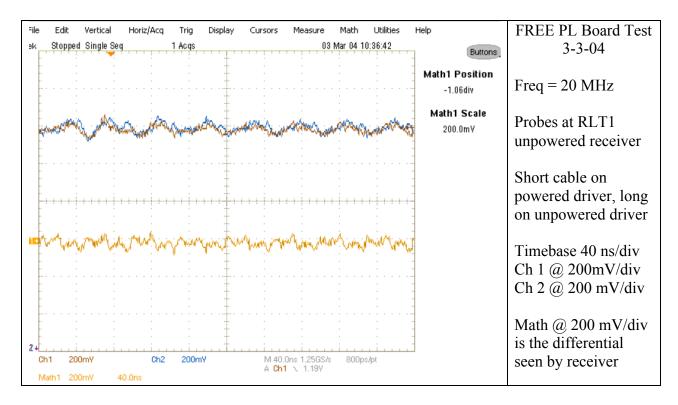
In this proposal, cabling reflections from the unterminated, unpowered driver side are quite significant with flight length cables. At the nominal 20 MHz clock rate, this fix does not function reliably. SLAC has agreed to configure the GASU to drop the clock rate to approximately 1 MHz for 1 second at FREE board turn on to mitigate this problem. At the 1 MHz rate, the reflections do not hinder operation and the FREE card redundant (unpowered) receiver will receive clocks reliably (which is the goal of this modification). After 1 second, SLAC will command the GASU to return the FREE card clock to the nominal 20 MHz rate for operations.

Powered receiver, 20 MHz. Implementation has no margin at 20 MHz as tested.

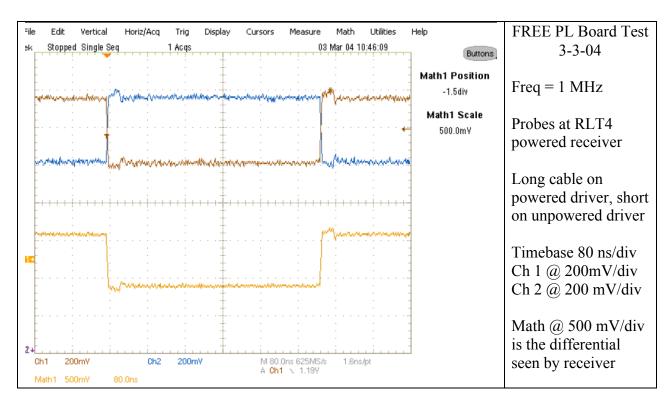
Powered side, 1 MHz, Differential signal is ~ 700 mV

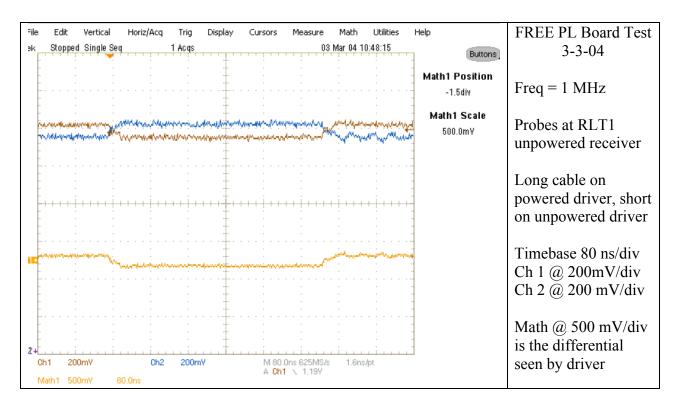
Unpowered receiver, 1 MHz, Differential signal is ~ 150 mV

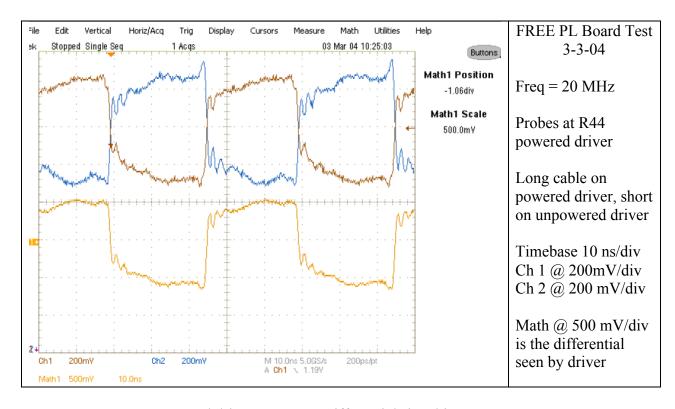
Powered driver, 20 MHz, Differential signal is ~ 700 mV

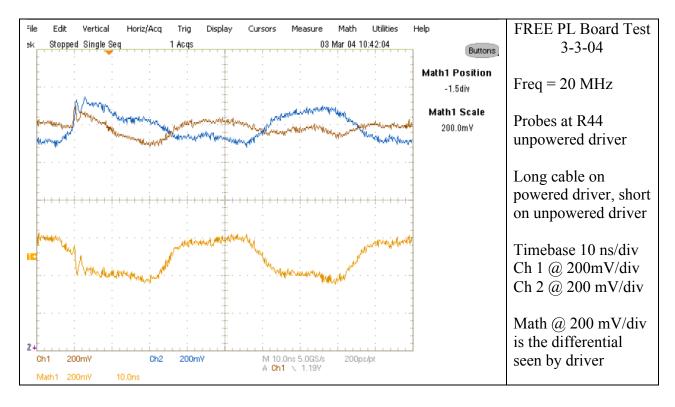
Unpowered driver, 20 MHz

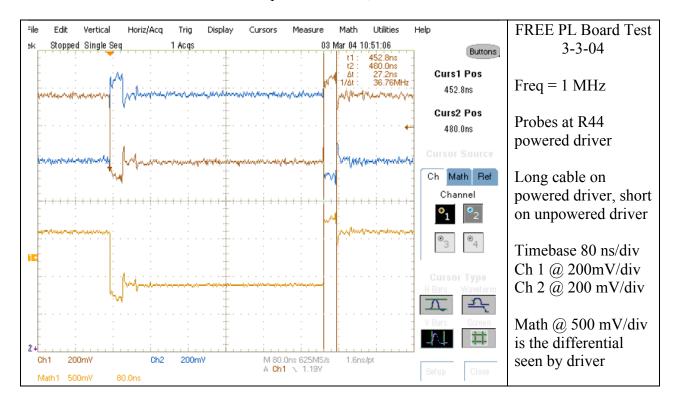
Powered driver, 1 MHz. Cable reflections cause discontinuity at 27 ns.
